Lake Jackson Dam

PHASE I: DATA COLLECTION AND EVALUATION

Project: Lake Jackson Dam

Subject: Toe Drain Investigation – Phase I: Data Collection and Evaluation

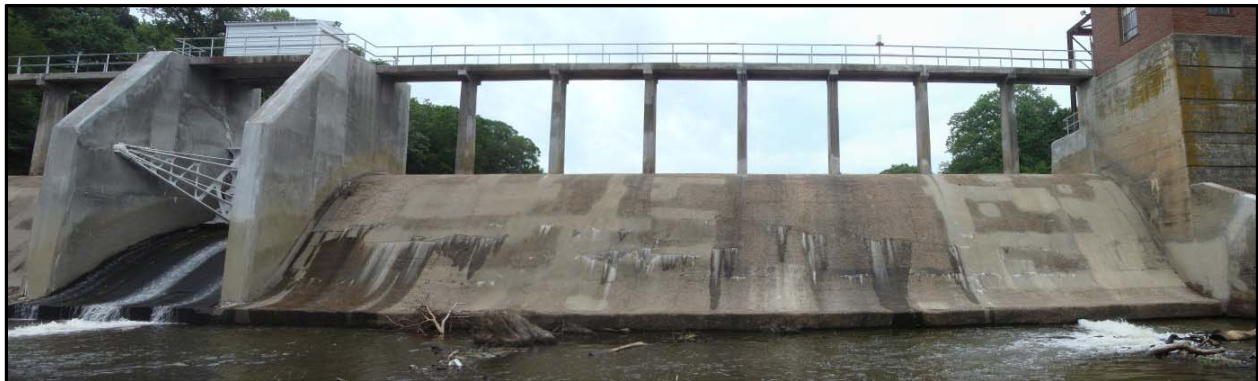
Seepage through the downstream face of the dam indicates that water is present within the spillway chambers. It was observed that the level at which seepage begins (where water is currently seeping out of the cracks and flows down on the face of the dam) is relatively uniform along the left portion of the spillway (looking downstream). This suggests that there may be cross connection(s) between the chambers which would serve to equalize water levels within the chambers of the dam. The seepage appears to indicate that the water within the chambers is at approximate EL 140, which is above the tainter gate invert elevation (EL 138). Attachment 4 is a photograph that documents the approximate elevation of the water seepage at the downstream face during the site observation. While the seepage through the cracks does result in the wetting of the concrete and efflorescence staining, there is no measureable flow that was noted. Photograph 1 below illustrates the seepage that was noted compared to the 2011 Dam Inspection which was conducted in July 2011 at which time no visible evidence of seepage was noted.

Photograph 1: Seepage through Downstream Face (July 2012)

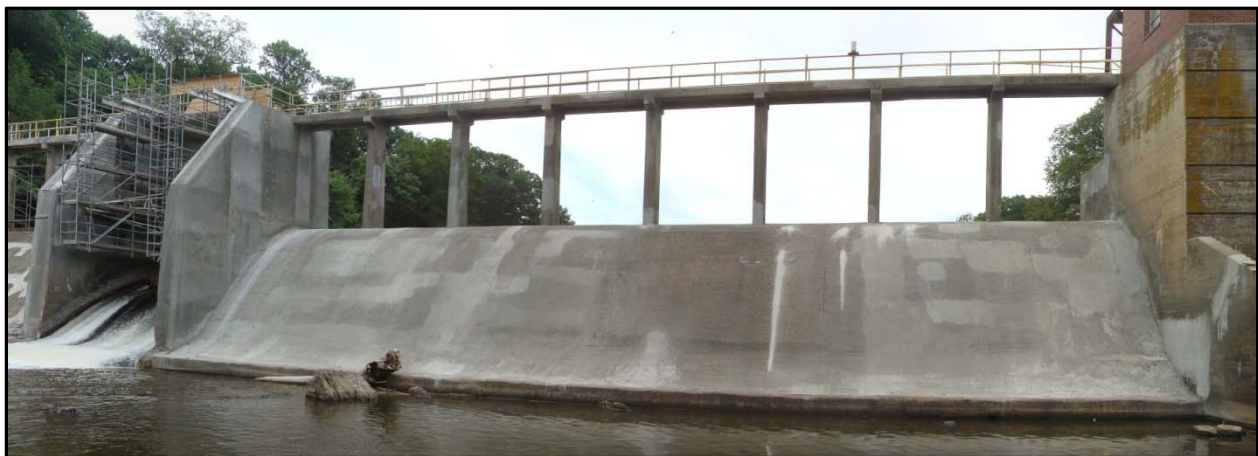
Photograph 2: No Seepage through Downstream Face (July 2011)

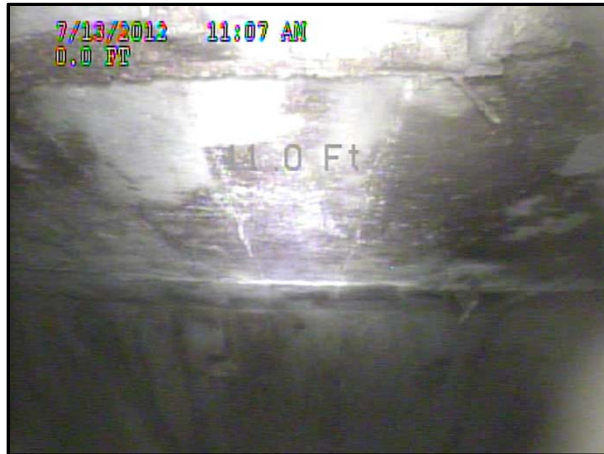
In addition to the measurements of the seepage on the downstream face of the dam, a CCTV camera was inserted into the air vent holes between Pier 1 and Pier 2. Through this investigation, it was determined that water was present and appeared to support the findings of the seepage measurements. In addition, the investigation did determine that concrete/rock was located approximately four (4) feet below the water level within the within that portion of the structure.

Photograph 3: Image from CCTV at End of Air Vent

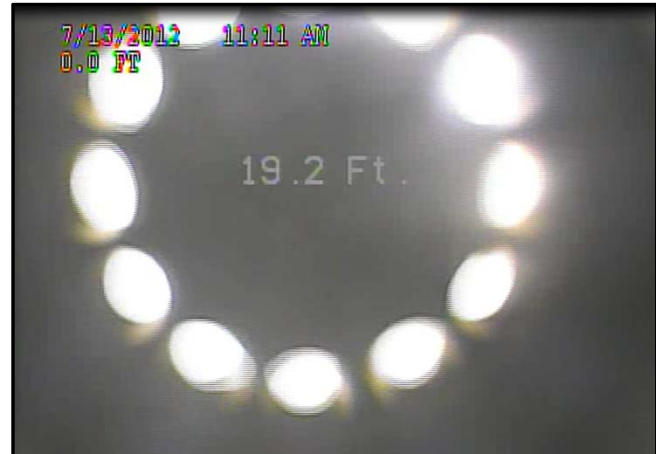
Photograph 4: Image at Water Level within Chamber (reflection of CCTV lights)

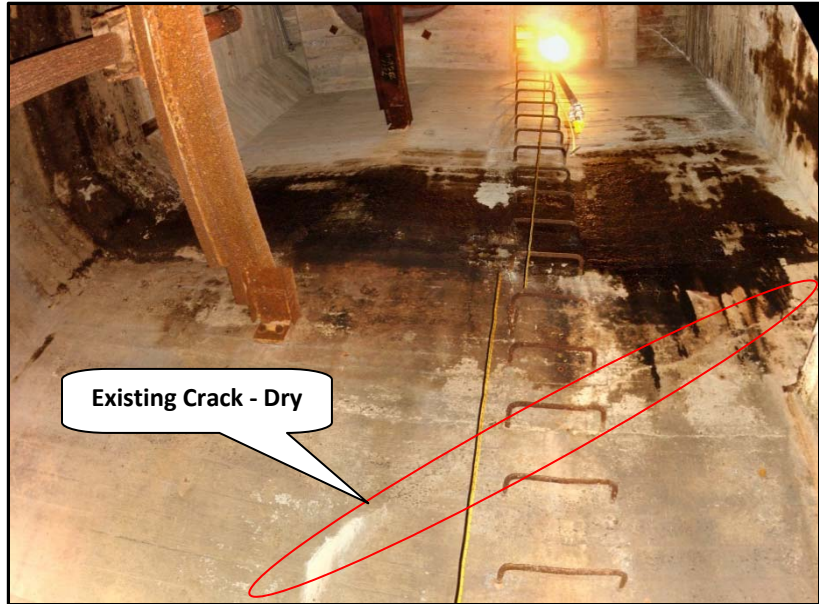
An internal investigation of the hydroelectric turbine chambers, which shares a common concrete wall with the concrete spillway, was conducted. This investigation was completed to assess if there was an access into the spillway chambers from that side of the dam. After this investigation, it was determined that an access to the spillway chambers does not exist from the hydroelectric turbine chambers and there is no apparent seepage through the common wall with the spillway. Overall the concrete is in good condition for its age. One crack was noted, which is illustrated in red on Photograph 6, is diagonal and extends from the lower left to the upper right through the steps shown in the photograph; but there was no apparent seepage near the crack and the crack did not appear to have formed recently.

Photograph 6: Investigation of Hydroelectric Turbine Chambers

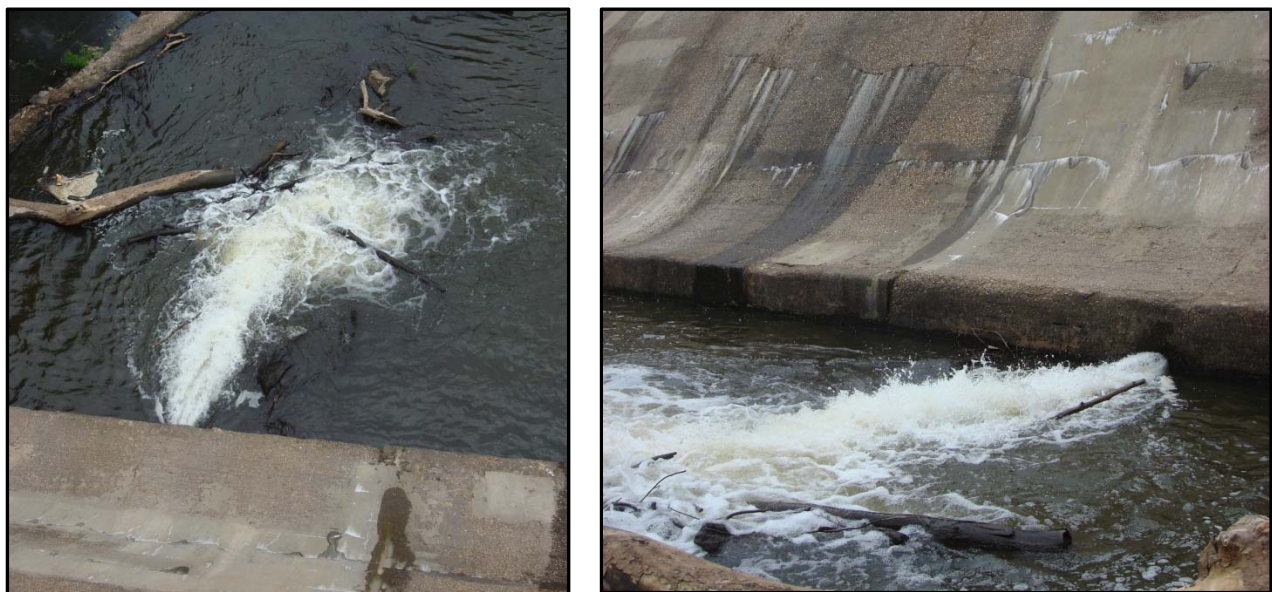
As described above, the activation of the toe drains was noticed by the County in late May 2012. Since that date, the flow rate has appeared to increase over time. The flow observed from the drains is in excess of 50 gallons/minute at each toe drain location (approximate - based on visual observation) and was clear water. The flow from the drains appears to be coming from the spillway chambers; however, additional investigations are required to determine how the water is entering the spillway chambers.

Photograph 7 & 8: Flow from Left Toe Drain

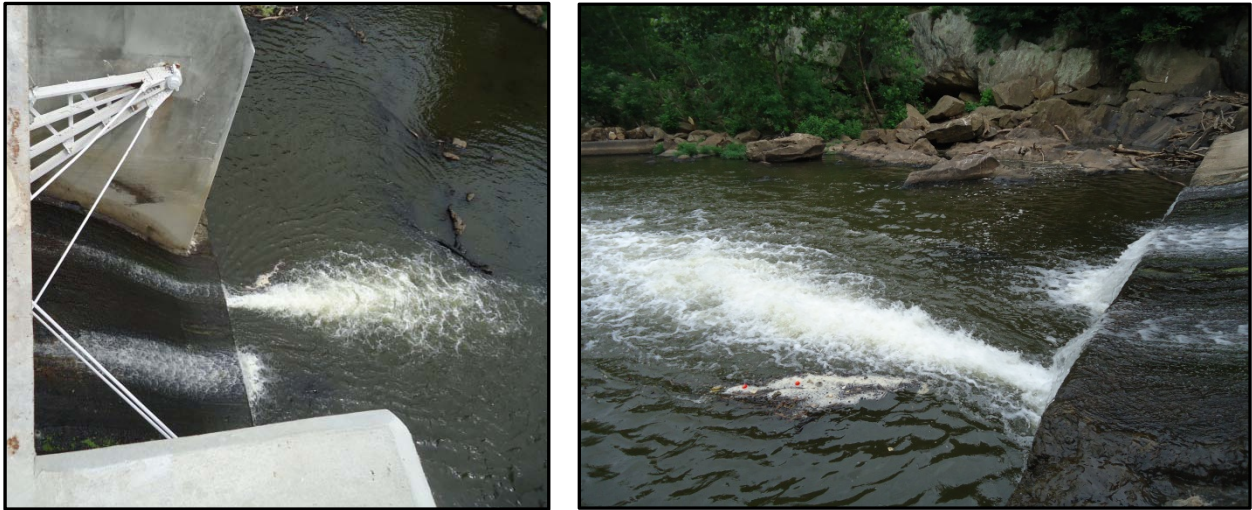
Photograph 9 & 10: Flow from Right Toe Drain

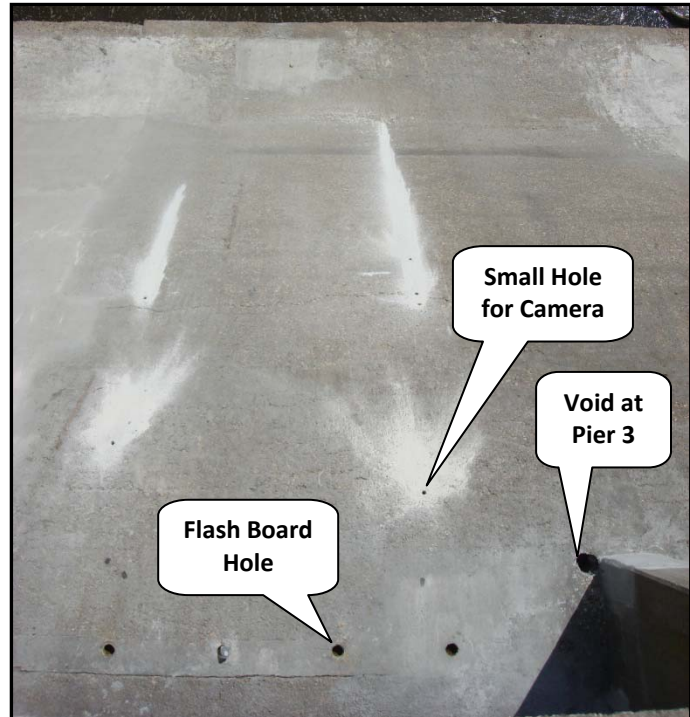
During the repair of the concrete, a void in the concrete at the crest of the dam was observed adjacent to Pier 3 (Pier 3 is noted as P3 in Attachment 2). The County conducted surface-penetrating radar and borescope surveys to determine the extent of void. The results of these surveys were inconclusive. Several small holes were drilled on the face of the dam in order to insert cameras and capture images of the void. During the inspection, a camera was inserted in the void and photographs were taken to determine the extent of the void. The photographs indicate that the inside face of the void was formed, and that the piers that extend up to the catwalk appear to extend down to the foundation of the dam and form interior chambers within the dam.

Photograph 10: Location of Void (July 15, 2011)

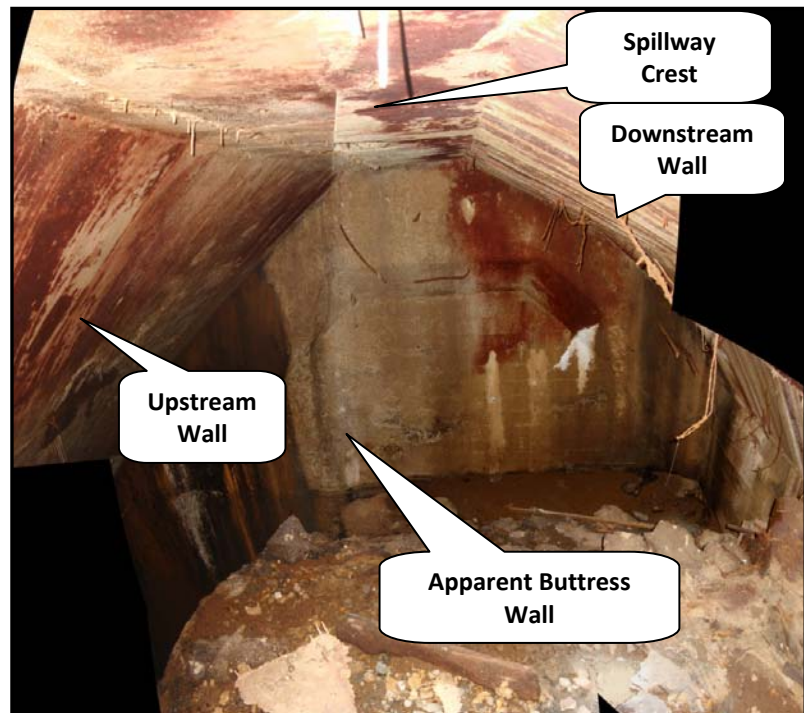
Photograph 11 is a composite of images taken by Baker at the time of the 2011 inspection. This photograph indicates that the upstream and downstream faces of the dam are formed on the inside. In addition, the vertical wall in the background is assumed to be the buttress wall at Pier 2. The photograph also indicates the presence of a separate mass that fills a portion of the interior cavity and the presence of construction debris at the bottom of the photograph. There does not appear to be an access hatch through the buttress wall based on Photograph 11. Additional investigation is required to fully understand the extent of the buttress walls and chambers. Also note that the chamber that was photographed in July 2011 was dry.

Photograph 11: Extent of Chamber (July 15, 2011)
